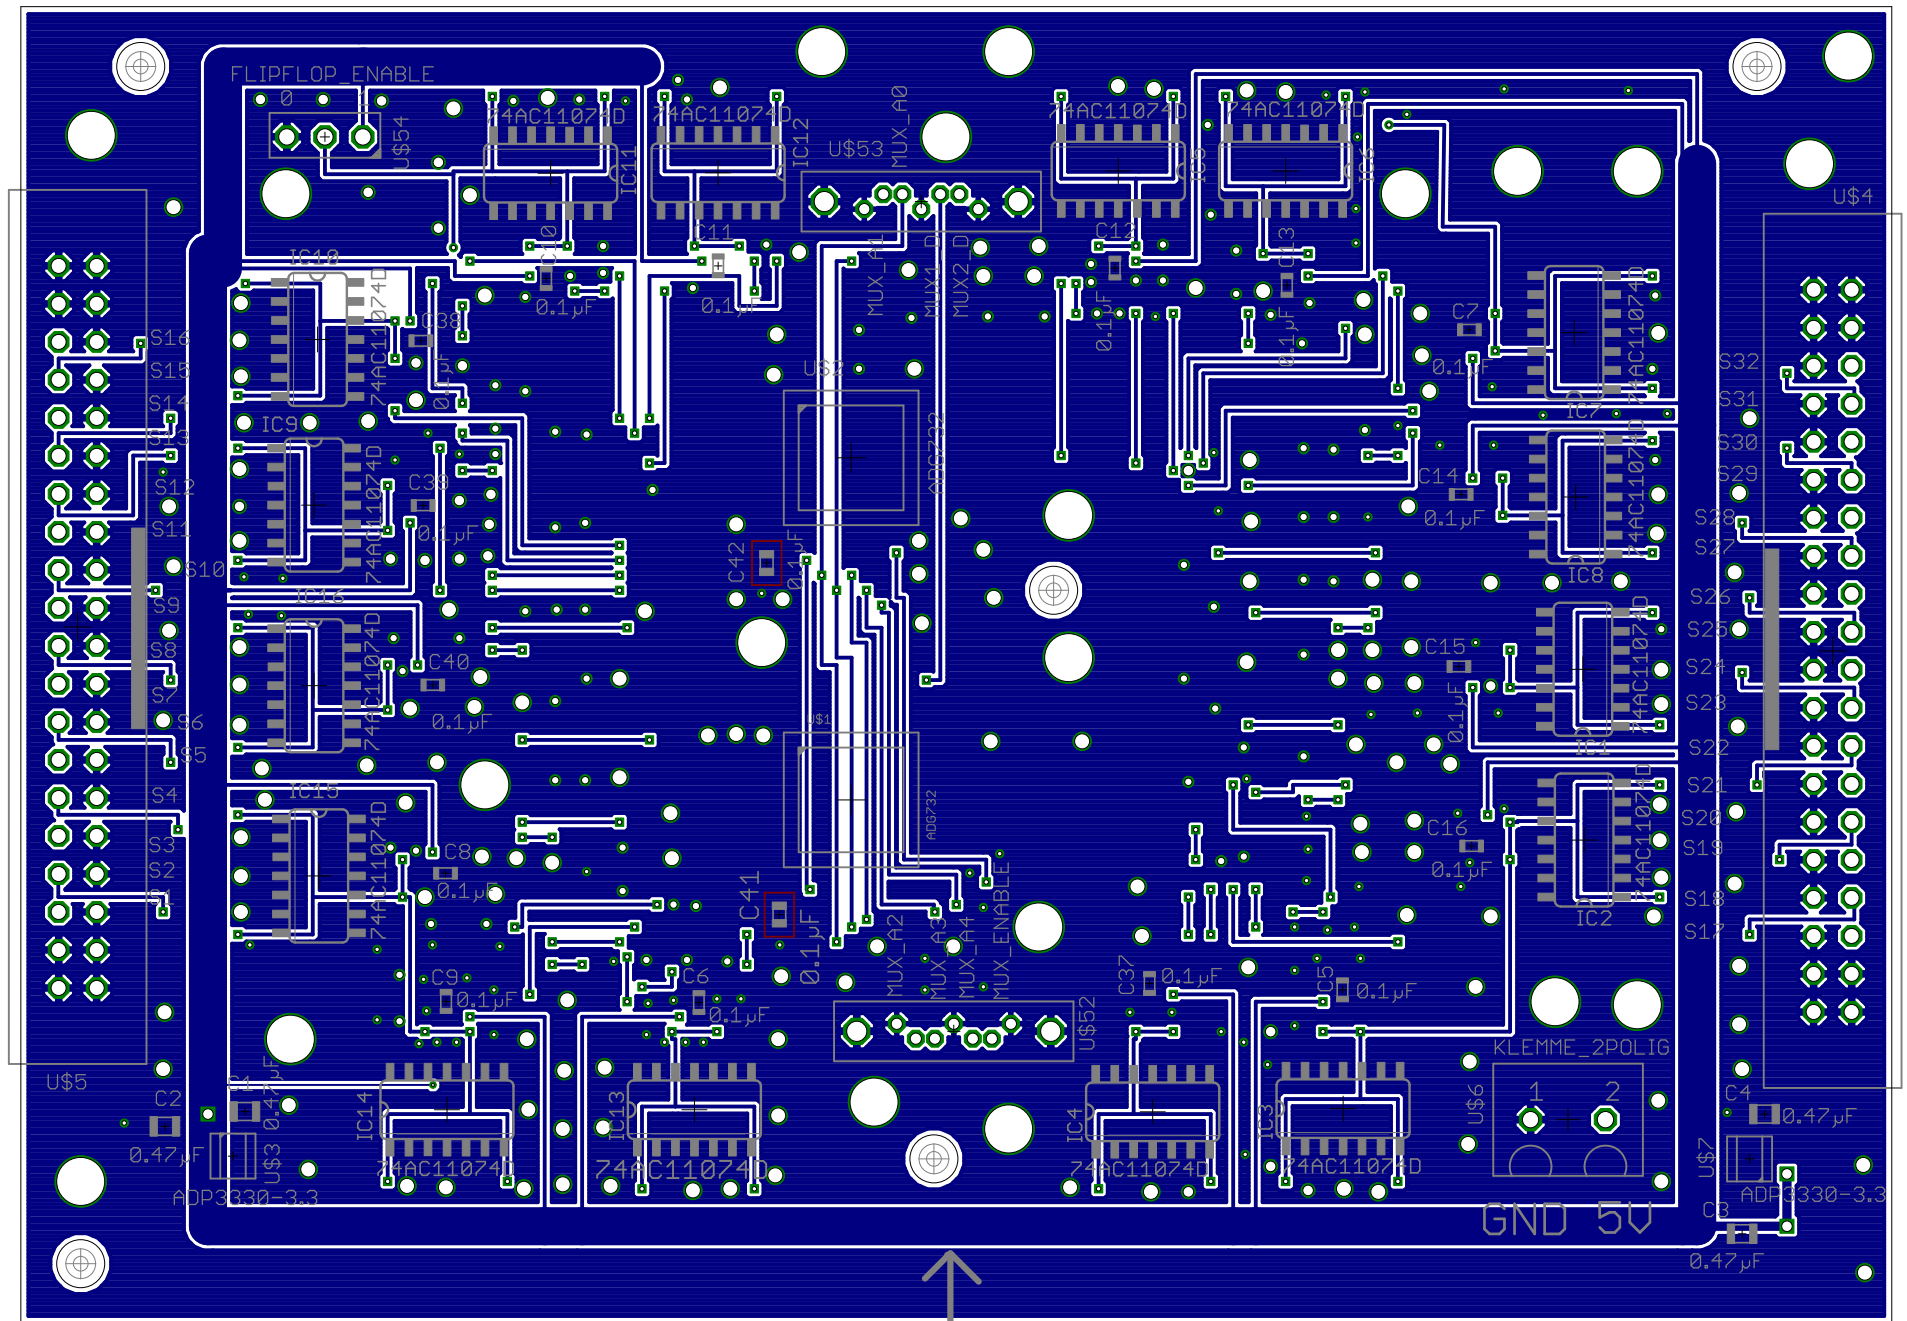
Cut Backside 3.3V Wire here
Otherwise problems will emerge
